**Nate Graham
4 West Main St.
Hastings-On-Hudson, NY 10706**

LEAD RISK ASSESSMENT REPORT

Date of Assessment: June 5, 2020

Date of Report: June 17, 2020

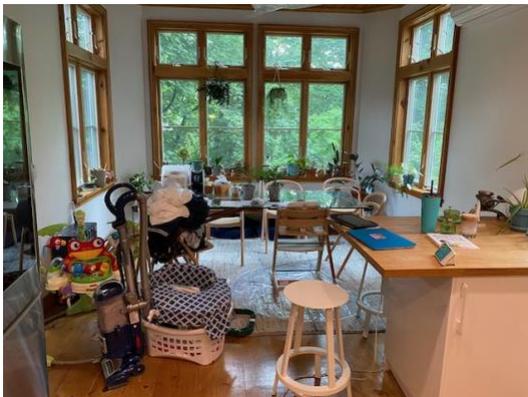
Figure (1) – Dining room

Sample Number	Location	Results
Wipe #01	1 st Fl L/R	<10 µg/ft ²
Wipe #03	1 st Fl Kitchen	<10 µg/ft ²
Wipe #04	1 st Fl D/R	<10 µg/ft ²
Wipe #05	1 st /2 nd Fl Staircase Landing	<10 µg/ft ²
Wipe #06	2 nd Fl Baby's Room	<10 µg/ft ²
Wipe #09	3 rd Fl Bedroom	<10 µg/ft ²
Wipe #10	3 rd Fl Kitchen	<10 µg/ft ²
Wipe #12	Basement Laundry	<8 µg/ft ²
Wipe #13	Basement Family Room	<8 µg/ft ²

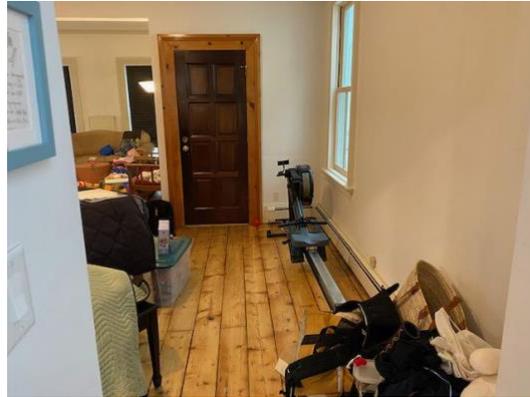
Figure (4) – Front Entrance

Sample Number	Location	Results
Wipe #02	1 st Fl Entrance	12.6 µg/ft ²

- 1st floor entrance between the living room and the kitchen
- 2nd floor master bed and the playroom next to the master bedroom
- Rear staircase from the 2nd to 3rd floor
- Staircase to the basement and landing at the bottom area

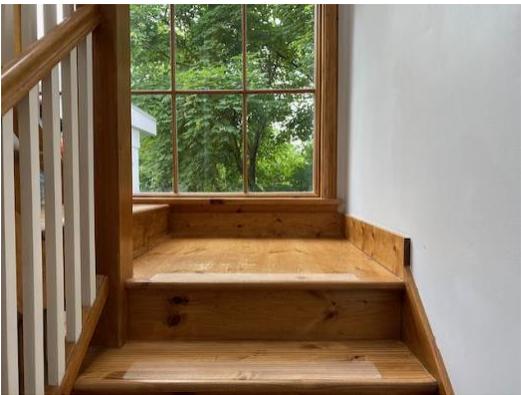
Figure (5) – Staircase landing to 3rd floor

Wipe #07	2 nd FI Master Bed	35.6 µg/ft ²
Wipe #08	2 nd /3 rd FI Staircase Landing	38.8 µg/ft ²
Wipe #11	Basement Staircase Landing	45.6 µg/ft ²

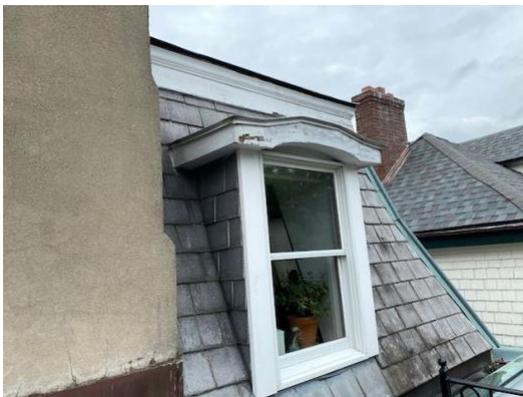
Figure (11) – Dommer window frame

Sample Number	Location	Result
Paint Chip #01	Ext. Dormer Trim 3 rd Fl	<0.009% By Weight

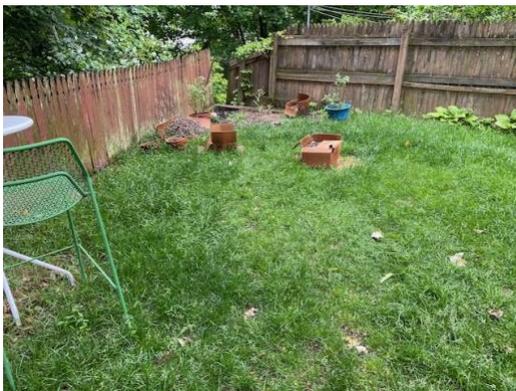
Figure (13) – Backyard

Sample Number	Location	Results
Soil #01	Front	774.8 µg/g
Soil #02	Front	697.6 µg/g
Soil #03	Rear	767.9 µg/g
Soil #04	Rear	773.7 µg/g

- 06-03-2020 Recommend to abate lead in soil near play areas and high-contact areas for children using Lead Abatement Methods described above in Section 6.0 for the following areas including flower garden in the front and backyard ground.

1. Replacement: 1-foot deep topsoil in the contaminated area can be removed and replaced with uncontaminated soil.
2. Enclosure: Provide a barrier between the contaminated soil and children by covering the contaminated bare surfaces with concrete or pavement.

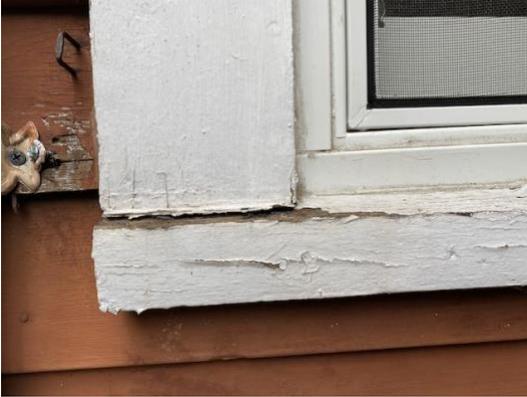
Figure (13) – Exterior window rear

Sample Number	Location	Results
Paint Chip #02	L/R Window Trim #1	2.604% By Weight
Paint Chip #03	L/R Window Trim #2	2.696% By Weight
Paint Chip #04	Exterior Wall Window #1 Front	1.161% By Weight
Paint Chip #05	Exterior Wall Window #2 Rear	0.571% By Weight

- 06-03-2020 Recommend to abate lead-based paint in the exterior and interior surfaces using Lead Abatement Methods described above in the Section 6.0 for the following areas:
- 1st floor living room window trims
 - Exterior walls including windows
